PART II (PART I IS IN THE JUNE 2003 EDITION)

## *Fire Sprinkler Systems* **Corrosion Related Failures**

### **FSS Design, Operation and Maintenance**

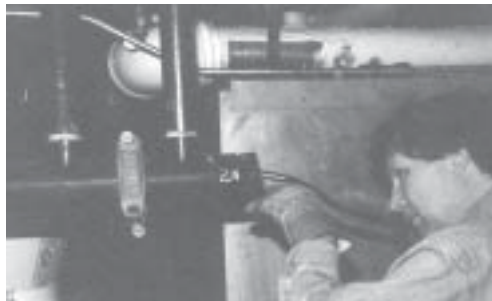
*Video-Borescope Inspection*

Internal video-borescope inspection — with experience, a diagnostic team can look in specific areas. Typically these types of inspections are on a selective basis and are based on previous experience, leak history, and the general layout of the FSS. An experienced team will be able to identify the susceptible areas to investigate. Leak history marked on

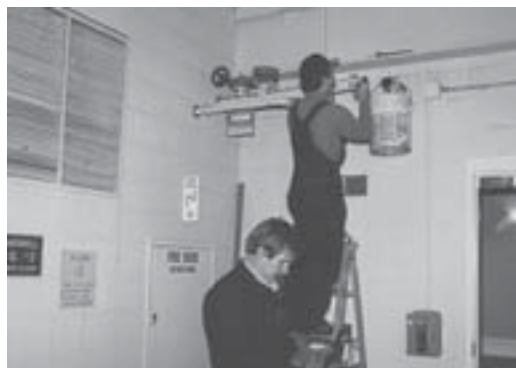
*Water Sampling*

Water Sampling to include water chemistry analyses and

microbiological culturing.
